Kaumalapau Harbor, Lanai, Hawaii, Two-Dimensional Breakwater Stability Study

Ernest R. Smith

February 2001

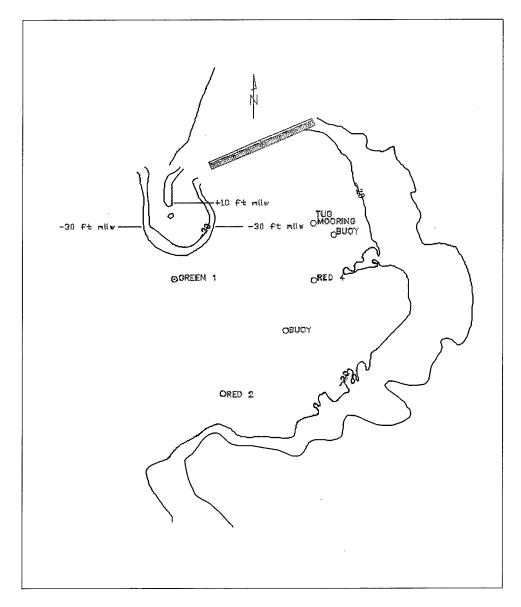
Figure 2. Kaumalapau Harbor

The harbor entrance is 183 m (600 ft) wide, opening into a semiprotected, 40,500-m² (10-acre) berthing area. Water depths in the berthing area range from 9.1 to 15.2 m (30 to 50 ft). The rubble-mound breakwater is approximately 76.2 m (250 ft) long with a crest elevation of about 3.0 m (10 ft). Commercial operations occur along a single 121.9-m (400-ft) wharf in the lee of the breakwater.

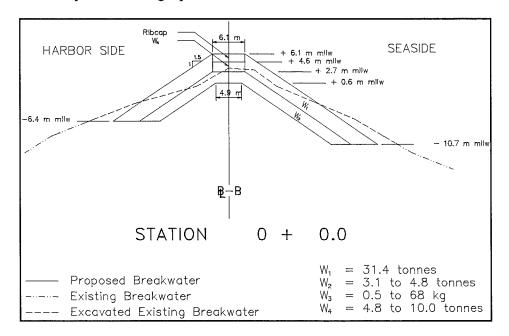
Figure 3. Typical cross section of proposed breakwater in previous study (Smith 1998)

Three-dimensional (3-D) physical model studies to evaluate harbor response to short-period waves and to evaluate stability of armor units placed on the breakwater were conducted in the same basin having a prototype depth of 29 m (95 ft) mean lower low water (mllw) at a 1:49 undistorted linear scale. The design wave height for the stability study was specified in a reconnaissance report as a 9.8-sec, 8.5-m (28-ft) deepwater wave and 7.1 m (23.4 ft) at the structure (U.S. Army Engineer District, Honolulu, 1993). The proposed breakwater consisted of CORE-LOC ® (hereafter referred to as Core-Loc) armor units placed on the existing structure, and the units extended from -10.7 m

(-35.1 ft) mllw on the sea side and -6.4 m (-21.0 ft) mllw on the lee side up to the crest elevation of +6.1 m (+20.0 ft) mllw. The crown width was 6.1 m (20 ft) wide and consisted of a rib cap. A sketch of typical cross section examined in the previous study is shown in Figure 3. Stability experiments were conducted on the proposed breakwater for waves exceeding the design height for 9.8- and 12-sec periods from 221- and 251-deg wave directions (Table 1). Core-Loc armor units were used in the stability study and placement density of units was defined by the following equation:

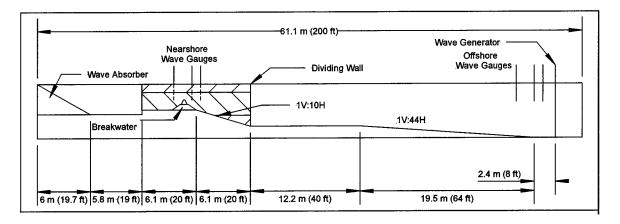
Figure 4. Wave tank used for study

Experiments were performed in a 61.1-m-long, 1.52-m-wide, 2.0-m-deep (200-ft-long, 5-ft-wide, 6-ft-deep) wave tank. Figure 4 shows tank dimensions, bottom slopes, wave gauge placement, and structure location for the study. The tank contained a concrete-capped compound slope to represent idealized local bathymetry seaward of the breakwater location. A 19.5-m-long (5.9-ft-long), 1V:44H slope originated at a model distance of 2.4 m (7.9 ft) from the wave board and represented a prototype depth of 77.0 m (252.6 ft) mllw. The 1V:44H slope terminated at a prototype depth of 52.9 m (173.6 ft) mllw, and was horizontal for 12.2 m (40.0 ft). A 1V:10H, which represented the nearshore bathymetry of the structure, extended for 6.1 m (20 ft) to a prototype depth of 19.8 m (65 ft) mllw. The model breakwater was constructed at the terminus of the 1V:10H slope on a 6.1-m-long (20-ft-long) horizontal section. Plywood was placed at the toe of the 1V:10H slope and extended to the end of the horizontal section to separate the tank into a 0.9-m-wide (3-ft-wide) section near the glass and a 0.6-m-wide (2-ft-wide) section near the far tank wall. The purpose of the plywood wall was to reduce the effect of re-reflected waves from the breakwater.

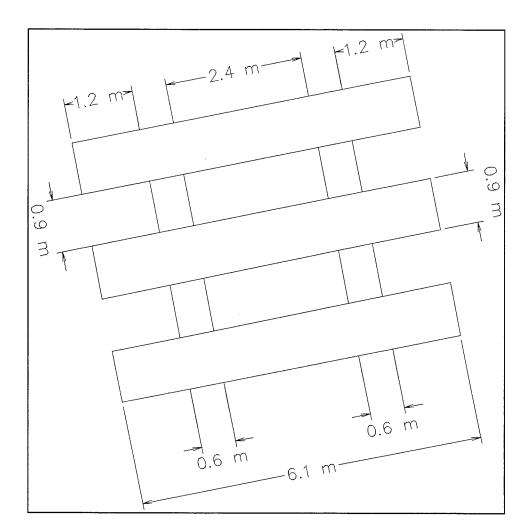
Figure 5. Dimensions of rib cap

The proposed change to the rib cap design consisted of decreasing the concrete ties from 0.9 m wide by 0.9 m deep (3 ft wide by 3 ft deep) to 0.9 m wide by 0.46 m deep (3 ft wide by 1.5 ft deep). The proposed change followed the precedent of previous rib cap designs and should provide adequate strength.

A rib cap was placed on the crown of the structure, and it was assumed that the rib cap would be stable in the prototype. Therefore, it was not necessary that the cap be dynamically similar to the prototype. The model rib cap, constructed of Plexiglas, was geometrically similar to the prototype and was anchored to the sidewalls in the model to ensure proper transmission, reflection, and dissipation of wave energy. Individual ribs were 0.9-m (3-ft) wide, 0.5-m (1.5-ft) high, 6.1-m (20-ft) long and spaced 1.8 m (6 ft) on centers. The ribs were oriented at a 90-deg angle to the longitudinal axis of the breakwater. The rib cap included 0.6-m-wide runners placed 1.5 m on center from the rib ends. A sketch showing rib cap dimensions is shown in Figure 5.

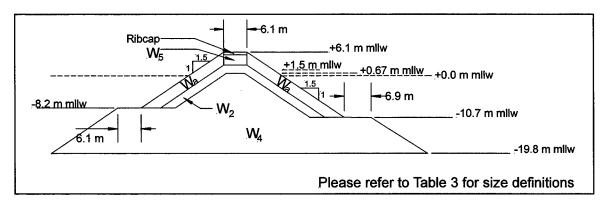
Figure 6. Cross section of Plans 1 and 2

The breakwater cross section, developed from the previous 3-D model study, was constructed to a crest elevation of +6.1 m (+20 ft) mllw with a rib cap (Figures 6 through 9). Core-Locs having prototype weights of 17.8 and 32.2 tonnes (19.6 and 35.5 tons) were placed to -10.7 m and -8.2 m (-35 ft and -27 ft) mllw toe elevations on the sea side and lee side, respectively. Results in the 2-D experiment were similar to the 3-D study for waves up to the design wave (9.8 sec, 6.9 m (22.6 ft) at the structure), with one unit displaced. However, for waves greater than the design condition, incident waves shoaled on the 1V:10H slope and the higher waves in the series broke on the structure, which was not observed in the 3-D study. In the 3-D study, waves did not transform as they approached the structure and much of the energy was transferred onto the leeside units as waves surged over the structure. Twenty-three seaside units and one lee-side unit were displaced for 12-sec 8.5-m (28.0-ft) waves during experiments of Plan 1 (Figures 10 through 12).

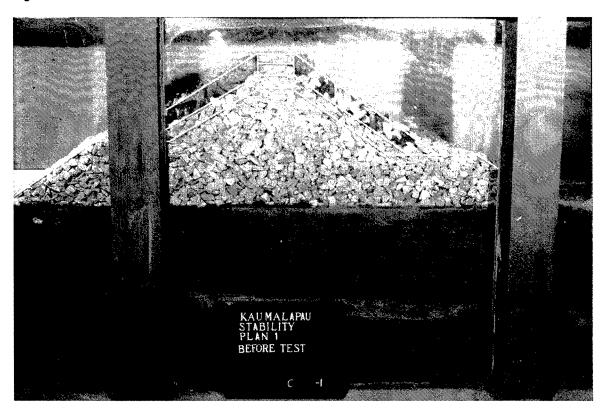
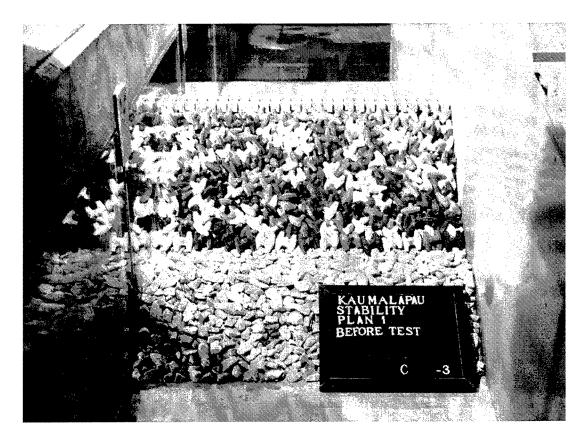
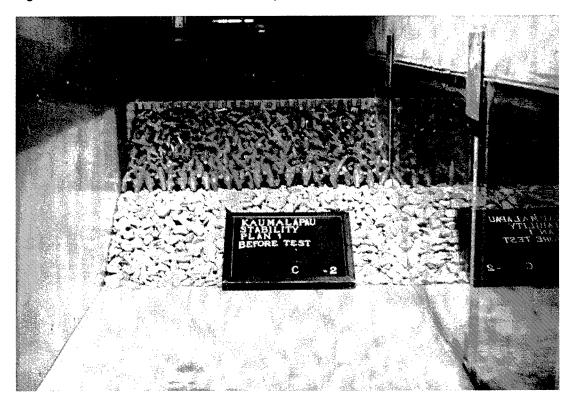
Figure 7. Side view of Plan 1, before experiment

Figure 8. Sea-side view of Plan 1, before experiment

Figure 9. Leeside view of Plan 1, before experiment

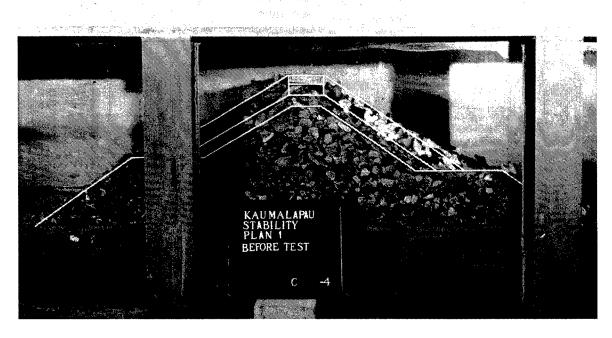
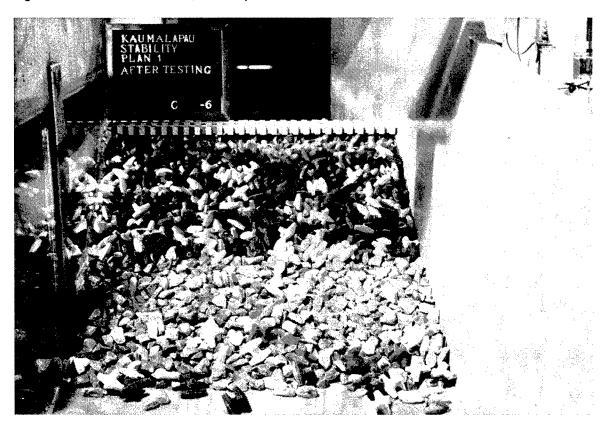
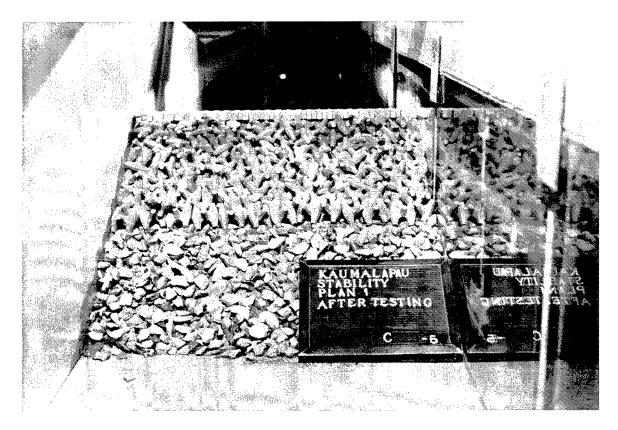
Figure 10. Side view of Plan 1, after experiment

Figure 11. Sea-side view of Plan 1, after experiment

Figure 12. Leeside view of Plan 1, after experiment

- a. The Core-Loc size, 17.8 tonnes (19.6 tons), used on the sea side in the 3-D study was not stable for 12-sec, 8.5-m (28-ft) waves.
- b. The heavier, 32.2-tonne (35.5-ton), Core-Loc appeared to be stable with no damage for waves up to 10.7 m (35 ft) if the depth of the armor toe was placed in sufficiently deep water (-19.8 m (-65 ft) mllw on the sea side, and -6.1 m (-20 ft) mllw on the lee side). On the sea side, toe stones were observed to rock in place and displace for incident waves in which the wave drawdown approached the depth of the toe. Displacement of toe stones led to subsidence of the armor layer and loss of interlocking between Core-Locs, which led to substantial damage to the breakwater. On the lee side, energy from overtopping waves displaced toe stones placed high in the water column, which led to leeside toe failure.

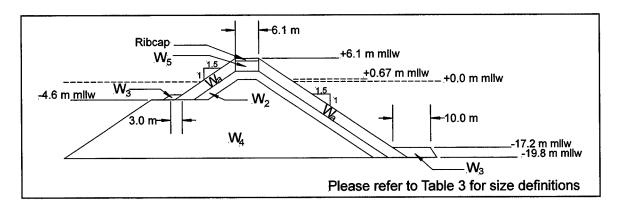
Figure 13. Cross section of Plan 3

From observations during Plan 2, instability at the toe caused the armor layer to slip and loosen the interlocking between Core-Locs. To determine if 32.2-tonne (35.5-ton) Core-Locs were stable, instability at the toe was minimized for Plan 3 by extending the sea-side Core-Loc toe to -19.8 m (-65 ft) mllw, fronted by a stone toe berm composed of 2.7-to 5.1-tonne (3.0- to 5.6-ton) stone (Figure 13). The toe of the lee side was stable on Plan 2, therefore the elevation

of the leeside toe was raised to -4.6 m (-15 ft) mllw and included a 3.0-m-(10-ft-) wide toe buttress of 2.7 to 5.1-tonne (3.0- to 5.6-ton) stone. The crest elevation remained at +6.1 m (+20 ft) mllw. Overtopping was similar to Plan 2; minor for waves less than 4.6 m (15 ft), moderate for 4.6-m (15-ft) waves, and major for 6.1-m (20-ft) waves and higher. Individual toe stones were displaced with 16-sec, 9.1-m (30-ft) waves, and the sea-side toe berm became rounded, but was stable. In general, little displacement of toe stones occurred on the sea side. However, overtopping waves began displacing leeside toe stones with 12-sec 7.6-m (25-ft) waves and continued to damage the leeside toe berm with higher waves. The structure remained stable through 12-sec 10.7-m (35-ft) waves, a total of two units were displaced on the sea side. However, many sea-side units were observed to rock in place for higher waves of individual wave series. The leeside units failed with 16-sec, 12.2-m (40-ft) waves due to toe failure caused by overtopping waves. The sea side appeared to be stable until a breach occurred from the lee side (Figures 14 through 16).

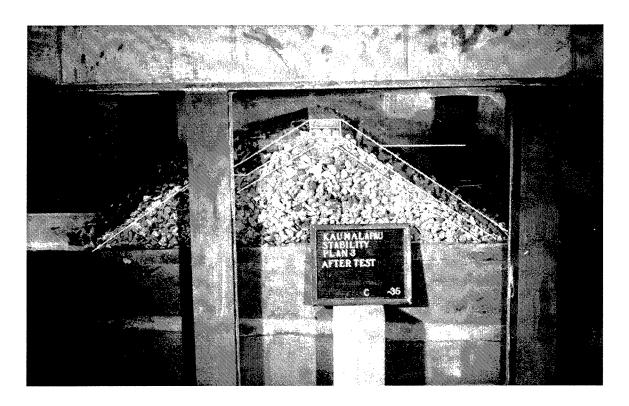
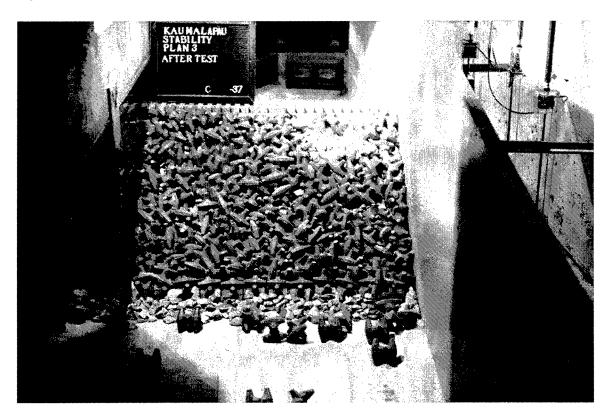
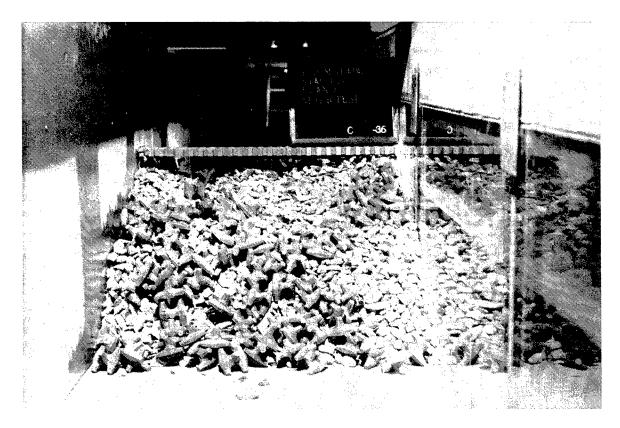
Figure 14. Side view of Plan 3, after experiment

Figure 15. Sea-side view of Plan 3, after experiment

Figure 16. Leeside view of Plan 3, after experiment

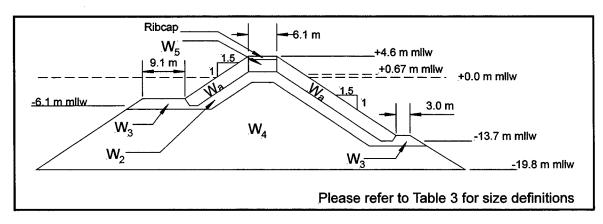
Figure 17. Cross section of Plan 4

Experiments were conducted on Plan 4, which consisted of 32.2-tonne (35.5-ton) Core-Locs. The seaside toe extended to -13.7 m (-45 ft) mllw and included a toe berm constructed of 2.7 to 5.1-tonne (3.0 to 5.6 ton-) stone, 3.0 m (10 ft) wide. The leeside toe extended to -6.1 m (-20 ft) mllw and also included a 2.7 to 5.1 tonne (3.0 to 5.6 ton-) stone to berm, 9.1 m (30 ft) wide. Additionally, the crest elevation was lowered from +6.1 m to +4.6 m (+20 ft to +15 ft) mllw (Figures 17 through 20). Minor overtopping occurred with 3.0-m- (10-ft-) waves with occasional water splashing onto the rib cap. Overtopping was moderate with occasional overtopping green water with 9.8-sec, 4.6-m (15-ft) waves. Major overtopping occurred with 6.1-m- (20-ft-) waves and higher. The structure was stable with minor damage on the sea side (one unit displaced, several rocking in place) with waves up to 12 sec, 12.2 m (40 ft). Toe stones began to rock in place on the sea-side berm with 12-sec, 4.6-m (15-ft) waves, and 12-sec, 7.6-m (25-ft) waves began to reshape the sea-side toe berm. Several toe stones were displaced with 12- and 16-sec, 10.7-m (35-ft) waves, but only one armor unit was displaced during 16-sec, 10.7-m (35-ft) waves, and the

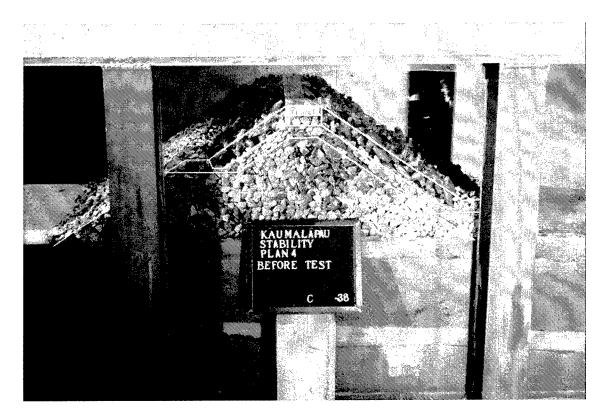
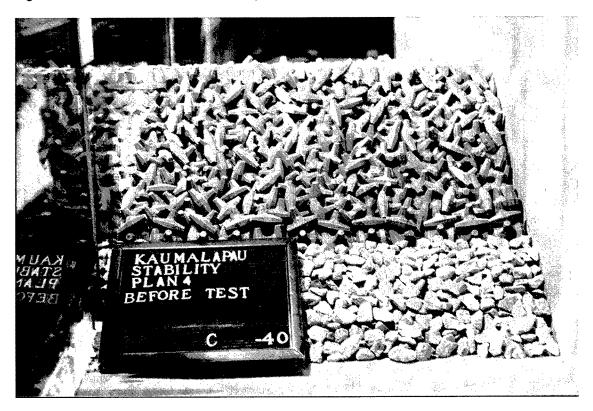
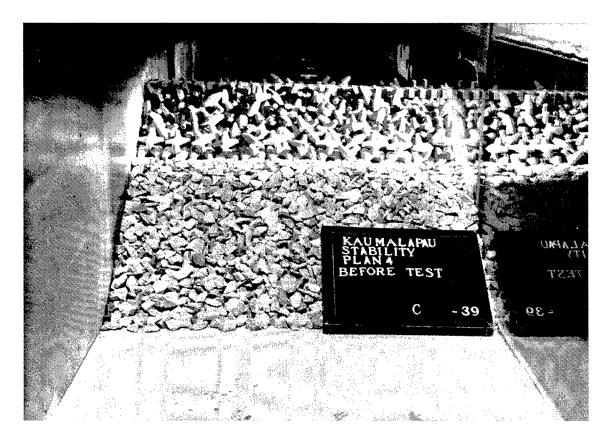
Figure 18. Side view of Plan 4, before experiment

Figure 19. Sea-side view of Plan 4, before experiment

Figure 20. Leeside view of Plan 4, before experiment

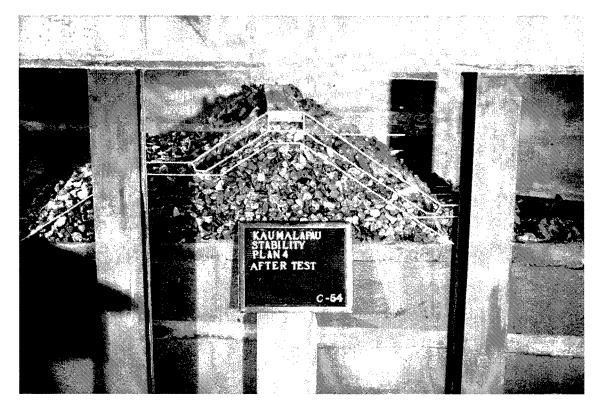
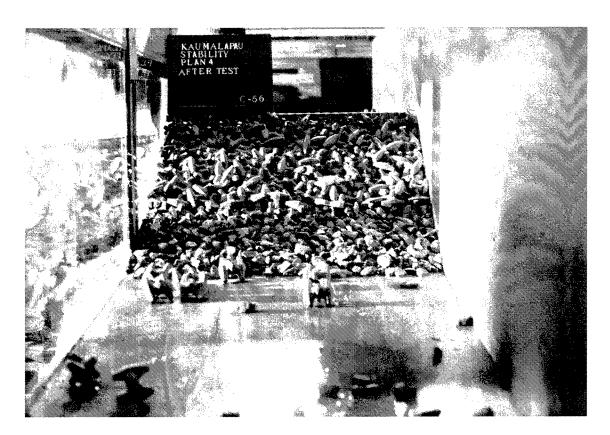
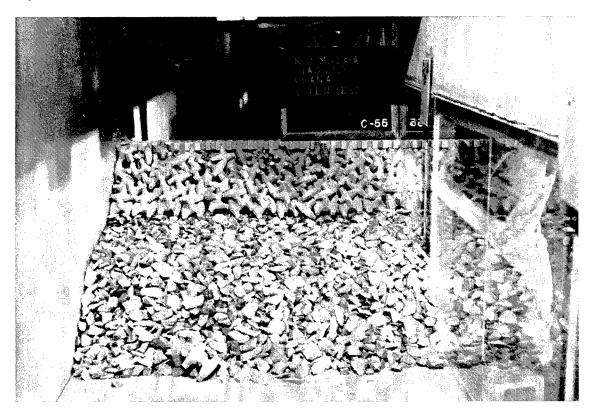
Figure 21. Side view of Plan 4, after experiment

Figure 22. Sea-side view of Plan 4, after experiment

Figure 23. Leeside view of Plan 4, after experiment

breakwater remained stable. Overtopping 16-sec, 10.7-m (30-ft) waves displaced leeside toe stones. The structure was moderately damaged with 16-sec, 12.2-m (40-ft) waves: 10 sea-side units and 2 leeside units were displaced (Figures 21 through 23). A portion of the damage appeared to result from looseness of the armor layer due to loss of toe stones.

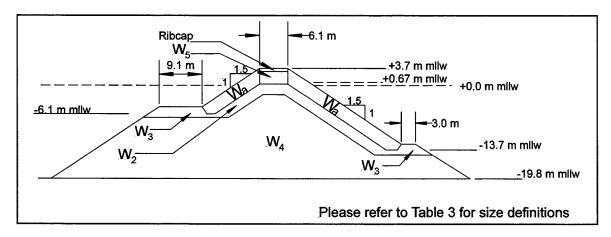
Figure 24. Cross section of Plan 5

Plan 5 was constructed using 32.2-tonne (35.5-ton) Core-Locs in the same configuration as Plan 4 except the crest elevation was lowered from +4.6 m (+15 ft) mllw to +3.7 m (+12 ft) mllw (Figure 24). Plan 5 was subjected to modified design wave conditions. Moderate overtopping occurred for 12-sec, 3.0-m (10-ft) waves. Overtopping was moderate to major for 12-sec, 4.6-m (15-ft) waves and major for 6.1-m (20-ft) waves and higher. Sea-side toe stones were observed to rock in place during 12-sec, 4.6-m (15-ft) waves and stones began to be displaced for 12-sec, 6.1-m (20-ft) waves. A scour hole began to form on the leeside toe berm for 16-sec, 7.6-m (25-ft) waves overtopping the structure and continued to be displaced for subsequent wave series of higher magnitude. Damage was minor after 12-sec, 12.2-m (40-ft) waves: three sea-side units and two leeside units displaced. Plan 5 had moderate to major damage after 16-sec, 12.2-m (40-ft) waves with a total of 18 sea-side and 4 leeside units displaced (Figures 25 through 27).

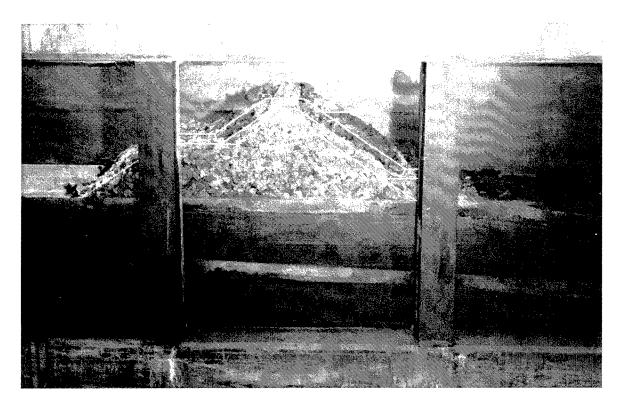
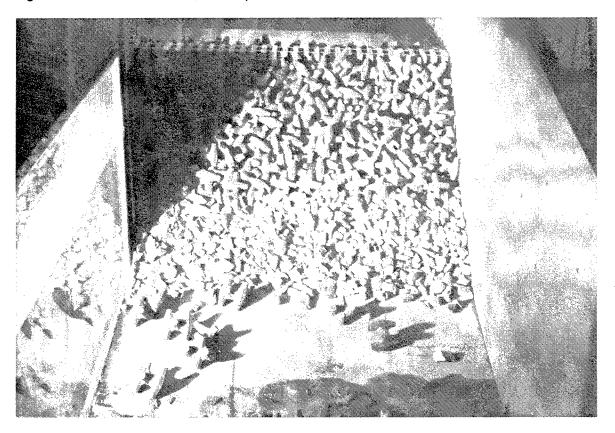
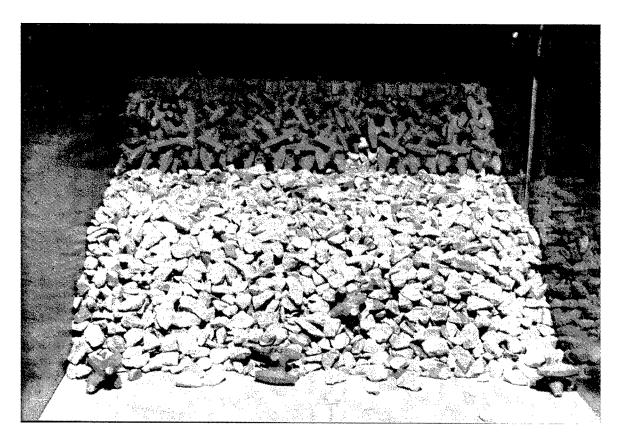
Figure 25. Side view of Plan 5, after experiment

Figure 26. Sea-side view of Plan 5, after experiment

Figure 27. Leeside view of Plan 5, after experiment
